Moglicë HPP - Albania

Jorge Terron

DEVOLL MOGLIČË PROJECT

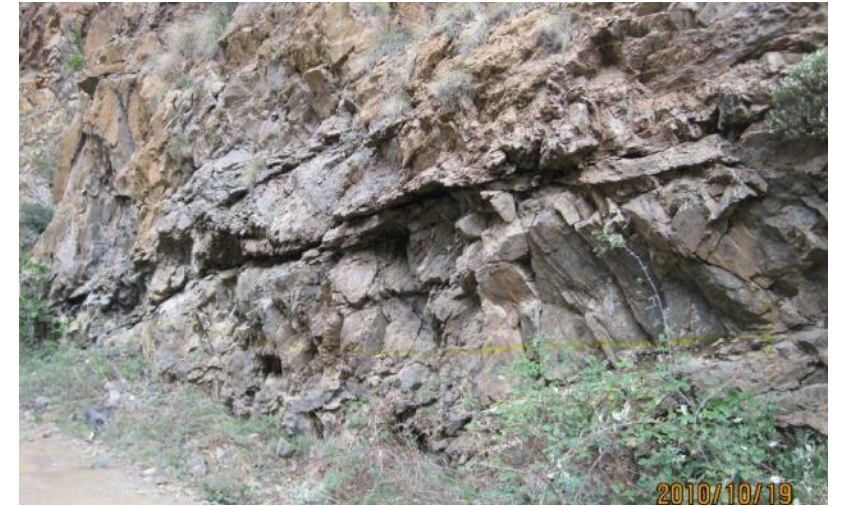
Cavern complex- Rock mass conditions interpreted from tunnels

- Mainly fair rock in tunnels, but poor in caverns
- Continuity of zones of 35-40m
- Lensed and undulated shapes
- Orientation of Long axis of caverns deemed favourable compared to main joint sets
- Stress measurements in Tender design => $SH = 20$ MPa, $Sh = 9.5$ MPa, $Sv = 9.5$ MPa. SH oriented NE-SW
- Convergence measurements wall-to-wall in tunnels showing closure of 12mm in fair rock

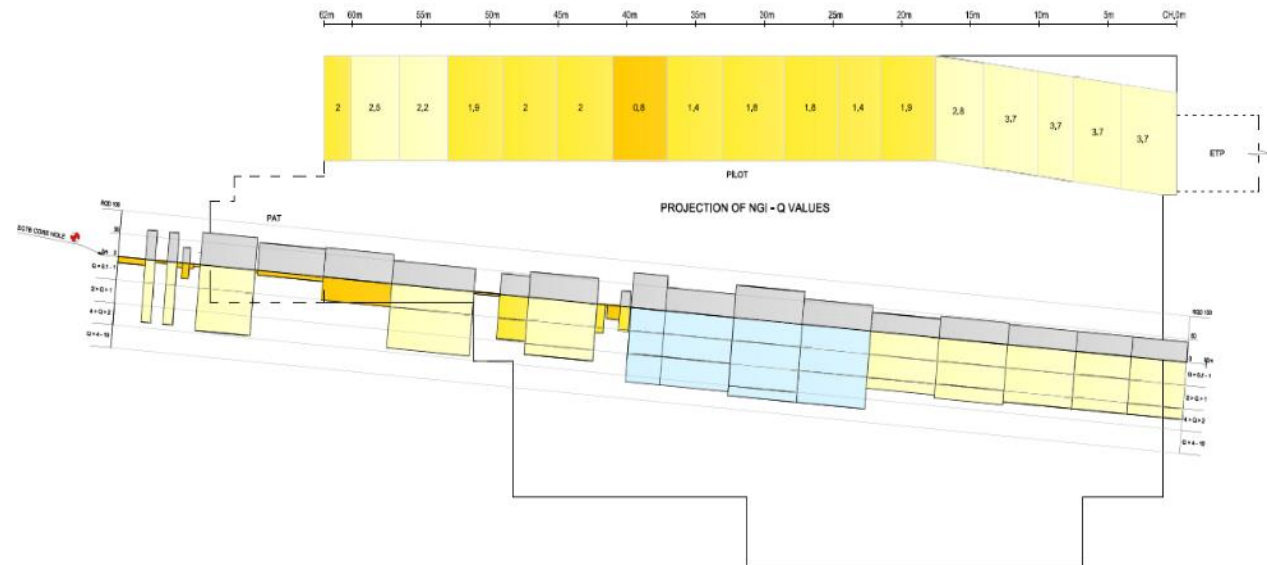
Cavern complex- Core drillings interpretation

- Jointed harzburgites with presence of zones
- High and rapid variability of fracturation
- West and upper part of the complex placed in a rock mass of poorer quality (Q1-3) and more serpentized
- Eastern and mid-lower part of the complex placed in rock mass of quality Q 2-4
- Reasonably tight rock mass $K 1 \times 10^{-8} \text{ m/s}$
- Medium-strong rock 40-75 MPa (intact rock strength)
- Brittle rock and many incipient joints

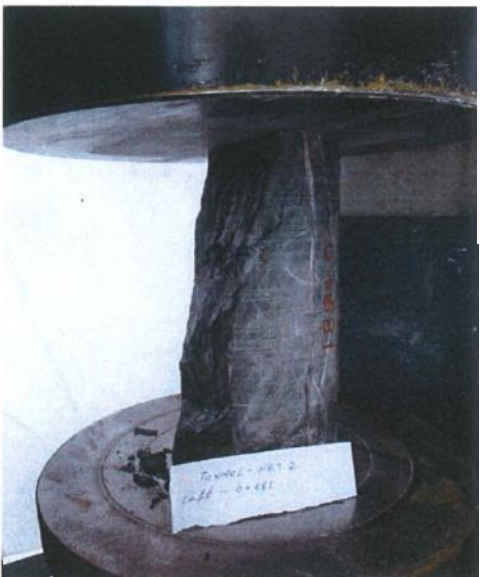
- Swelling pressure 0.02MPa for serpentinite infillings

Photo Tunnel HRT2, Chainage 0+681 (Left Side) After Testing

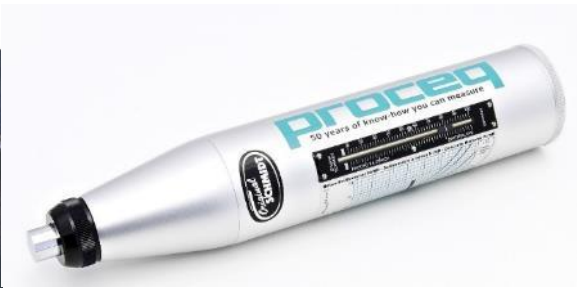
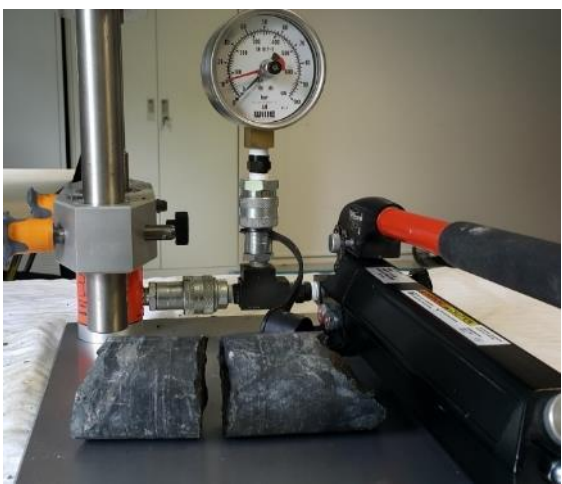
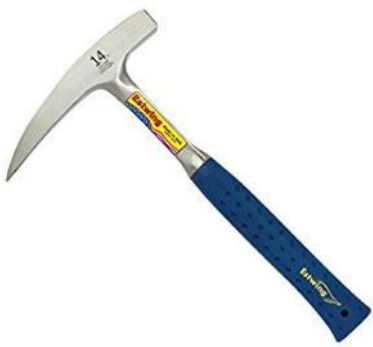
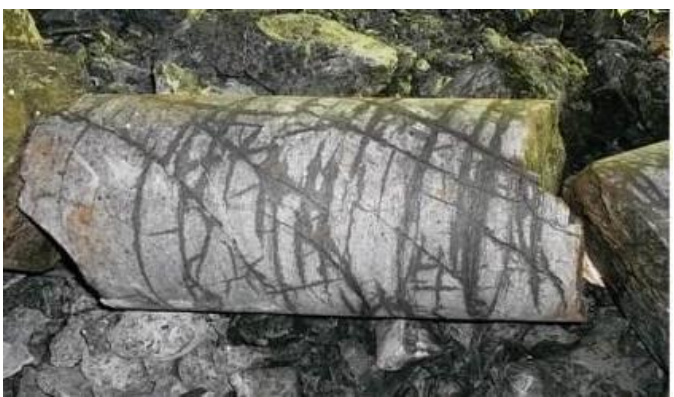
- In general, brittle rock. Reasonably strong rock compared to the low tensile strength.

Compressive strength (MPa)	Schmidt hammer	PLT Diametrical	PLT Axial	PLT lumps	UCS lab	UCS cubic sample
Max	94	51	76	46	75.7	-
Min	45	30	51	26	8.9	-
Mean	66.9	40.7	64	35	33.1	53.6
St. Deviation %	18.2	8	9	10	37	-

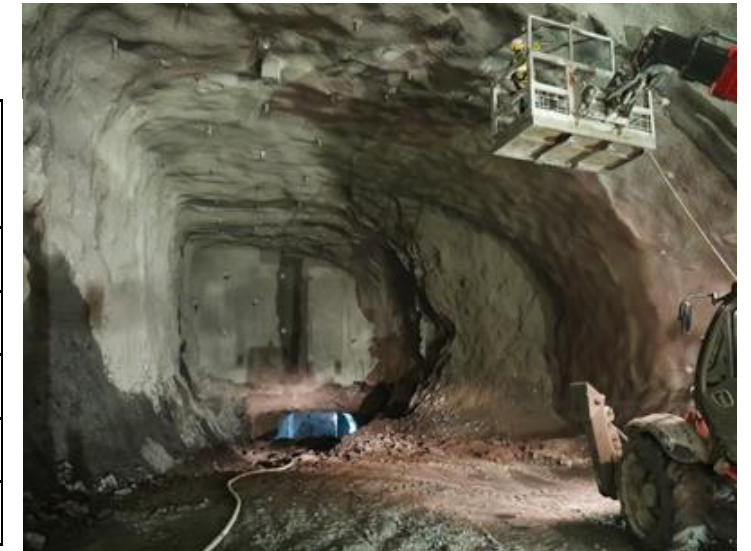
Cavern complex- Geomodel

- Geomodel interpretation based on site investigations (rock mass quality distribution)
- Update of geomodel with the observations done in pilot gallery
- Rock mass characterization based on mapping and measured deformations in the pilot gallery
- Strategy based on a continuous measuring of the system behaviour and update of rock mass properties

Rock class	NGI-Q	Max Q	Min Q	Mean Q	St. Dev	% Distr.
II	10-40	-	-	-	-	-
III	4-10	5.8	4.1	5.4	0.7	7.4
IV A-1	4>Q>2	3.8	2.1	2.9	0.5	47
IV A-2	2≥Q≥1	1.9	1.1	1.7	0.2	39.1
IV B	0.1-1	0.9	0.3	0.7	0.2	6.4

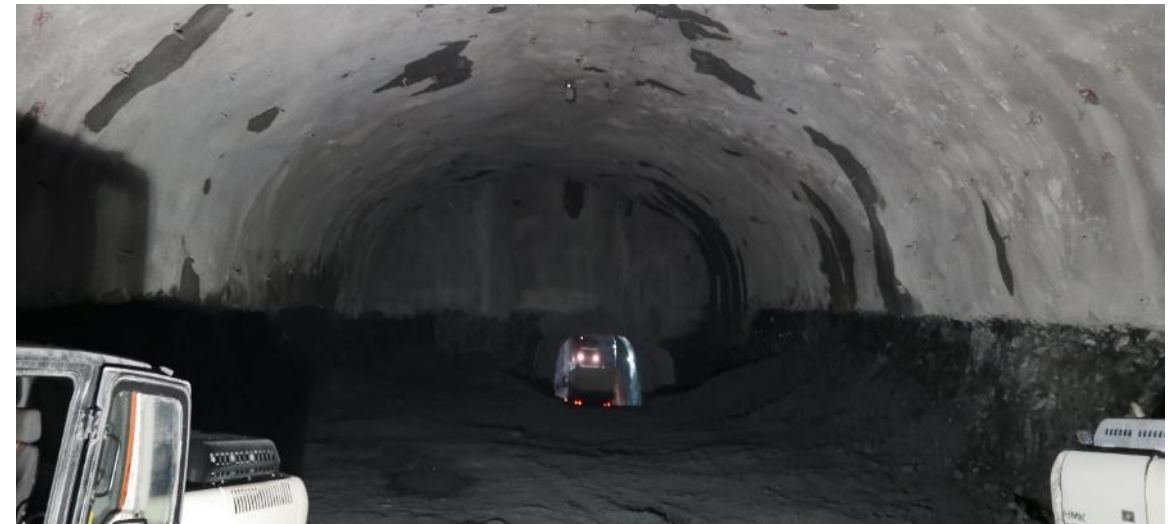
Cavern complex- Geomodel

- Back calculation of rock mass properties based first on comparison of measurements in roof.
- Monitoring and back calculations of rock mass properties are done during the excavation of both caverns

Rock mass properties	Rock units			
	III	IV A-1	IV A-2	IV B
Unit region	B	C	D	E
Mean Q	5	2.6	1.7	0.6
Mean GSI	48	43	38	31
UCS _m (MPa)	3.5	2.3	1.5	0.9
Young's modulus, E _m (GPa)	23.0	18	10.0	6.0
Poisson's ratio, ν _m	0.2	0.2	0.2	0.2
Density, ρ (kN/m ³)	33	33	33	33
Cohesion, C _m (MPa)	1.7	1.5	1.2	0.9
Tension, T _m (MPa)	0	0	0	0
Friction angle, Ø _m (°)	49	47	42	37
Dilatation angle, δ (°)	5.0	5.0	5.0	5.0

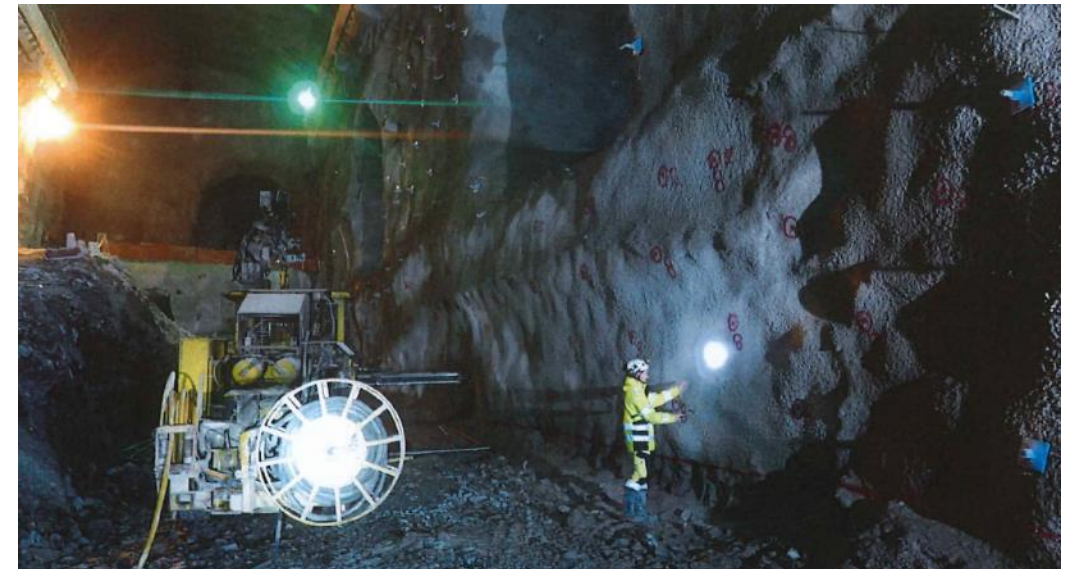
Cavern complex - Excavation

- Excavation from up to down in both caverns
- Excavation sequence adjusted to rock conditions in levels and benches
- Continuous monitoring after each excavation round
- Rock support installed at the face after each round
- Evidences of low tensile strength of rock when faces were unconfined
- FLAC analysis done with excavation steps
- Hold point inspections before any further benching

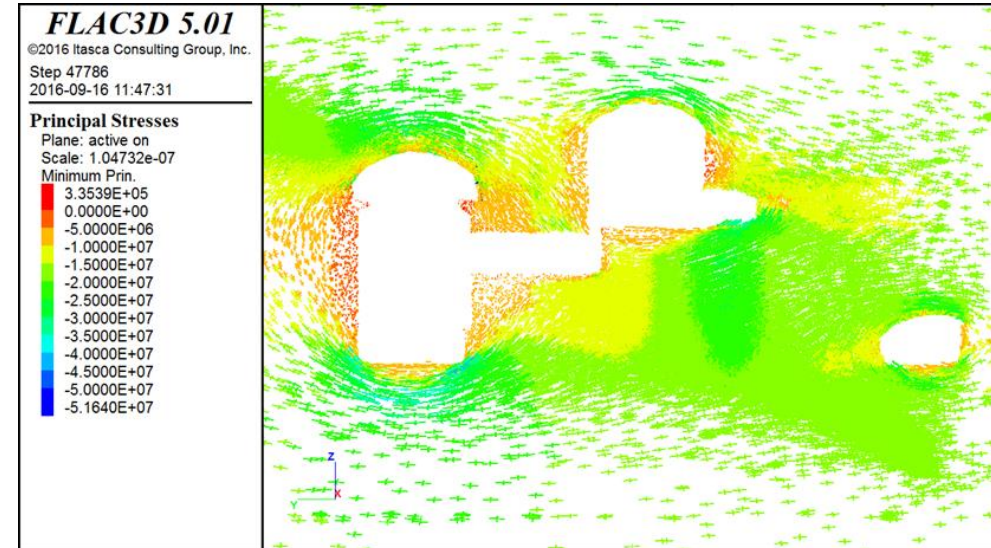
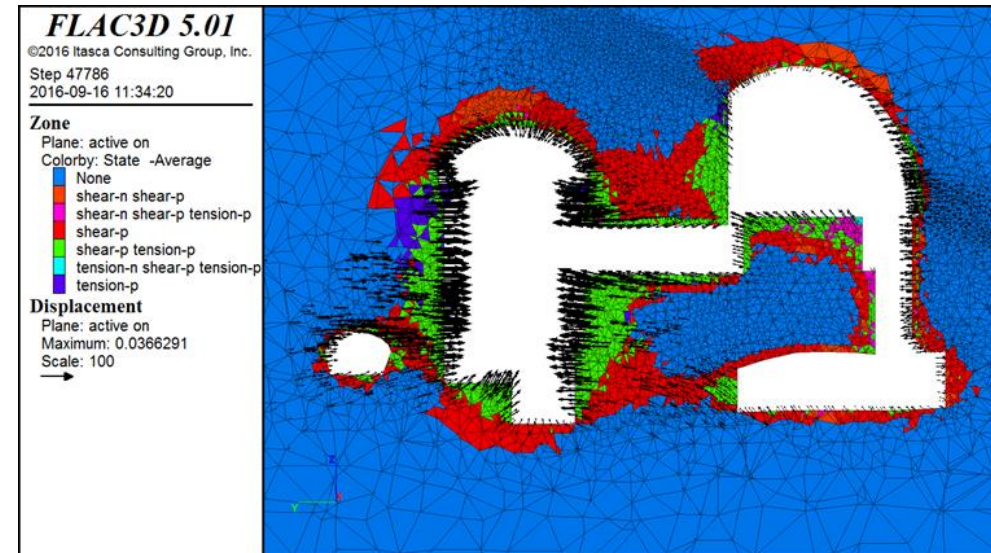
Cavern complex- Calculated response

- Calculations run in FLAC
- Stress state
 - Larger plasticisation in walls
 - Tensile failure in walls
 - Compression and arching in roofs
 - Shear and tensile failure in pillar
 - Shadow effect after both caverns excavated
- Displacements in crane beam level

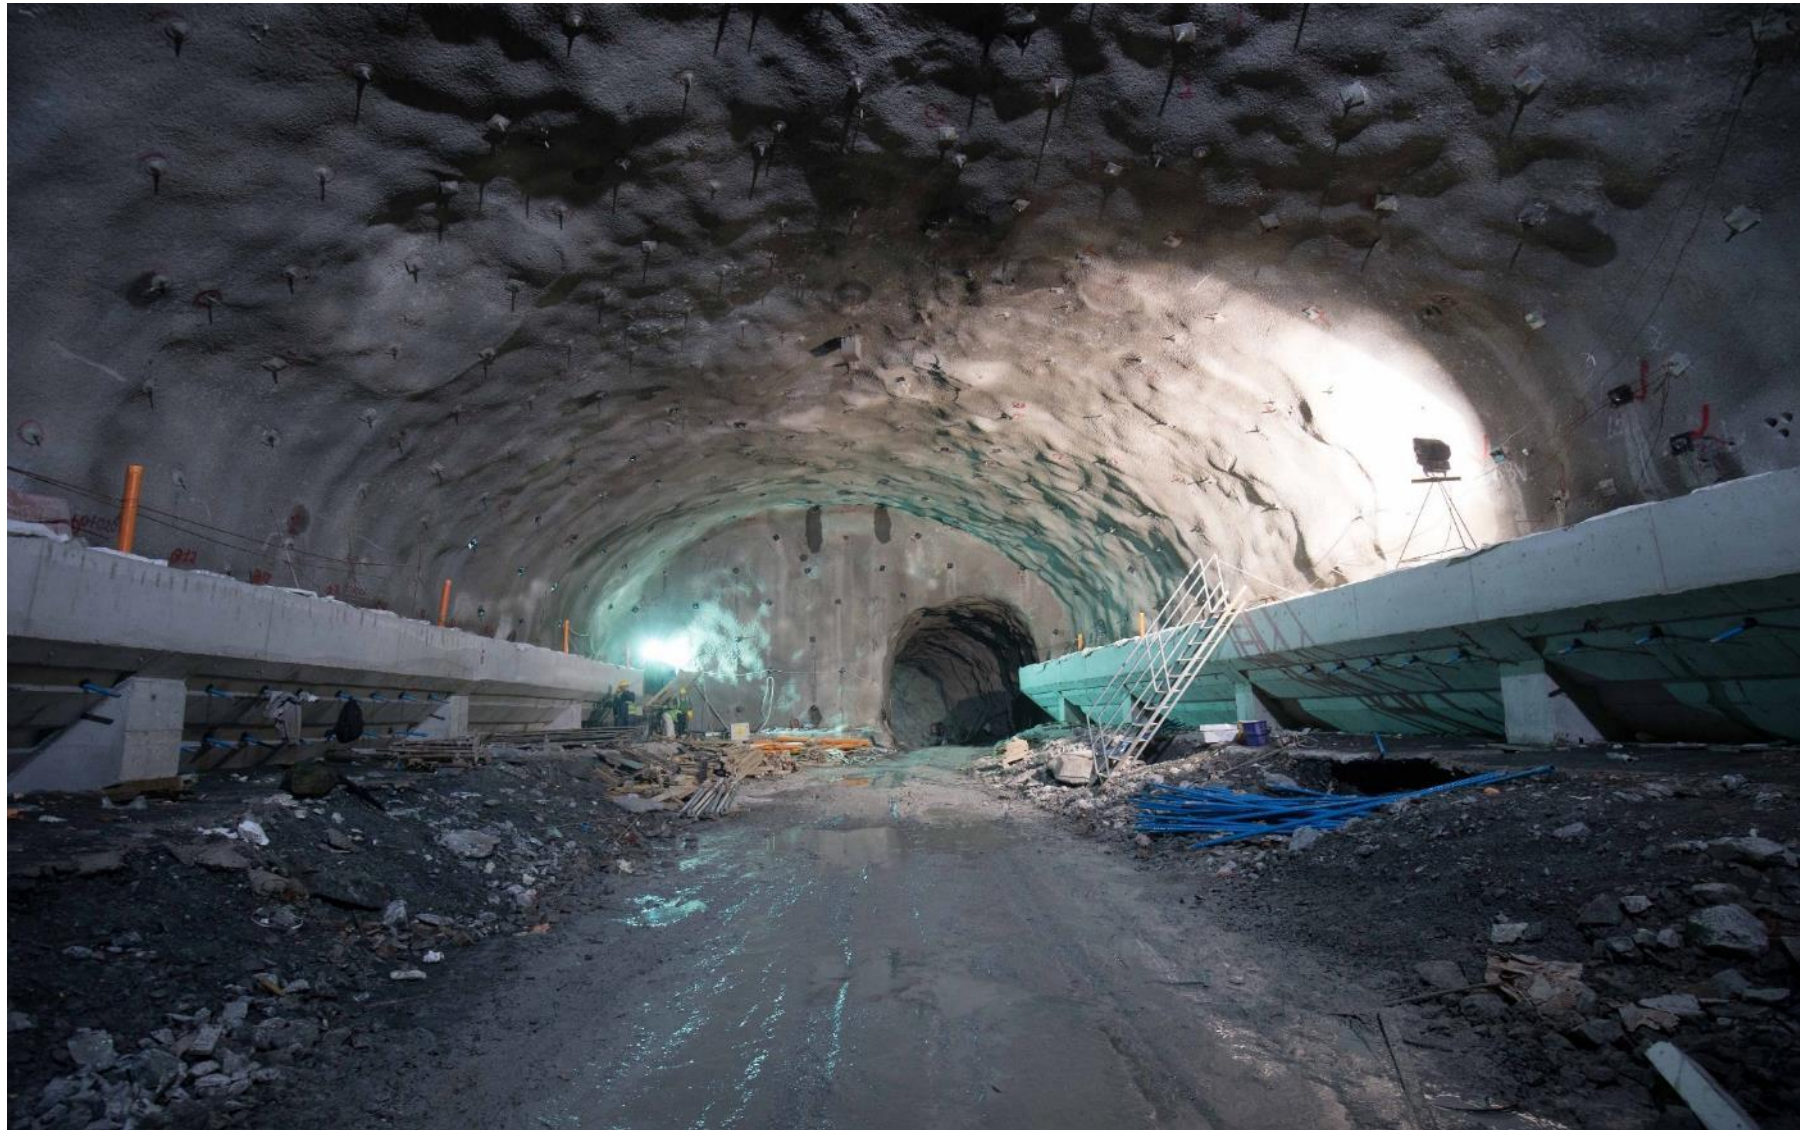
June 2016 crane beams casted

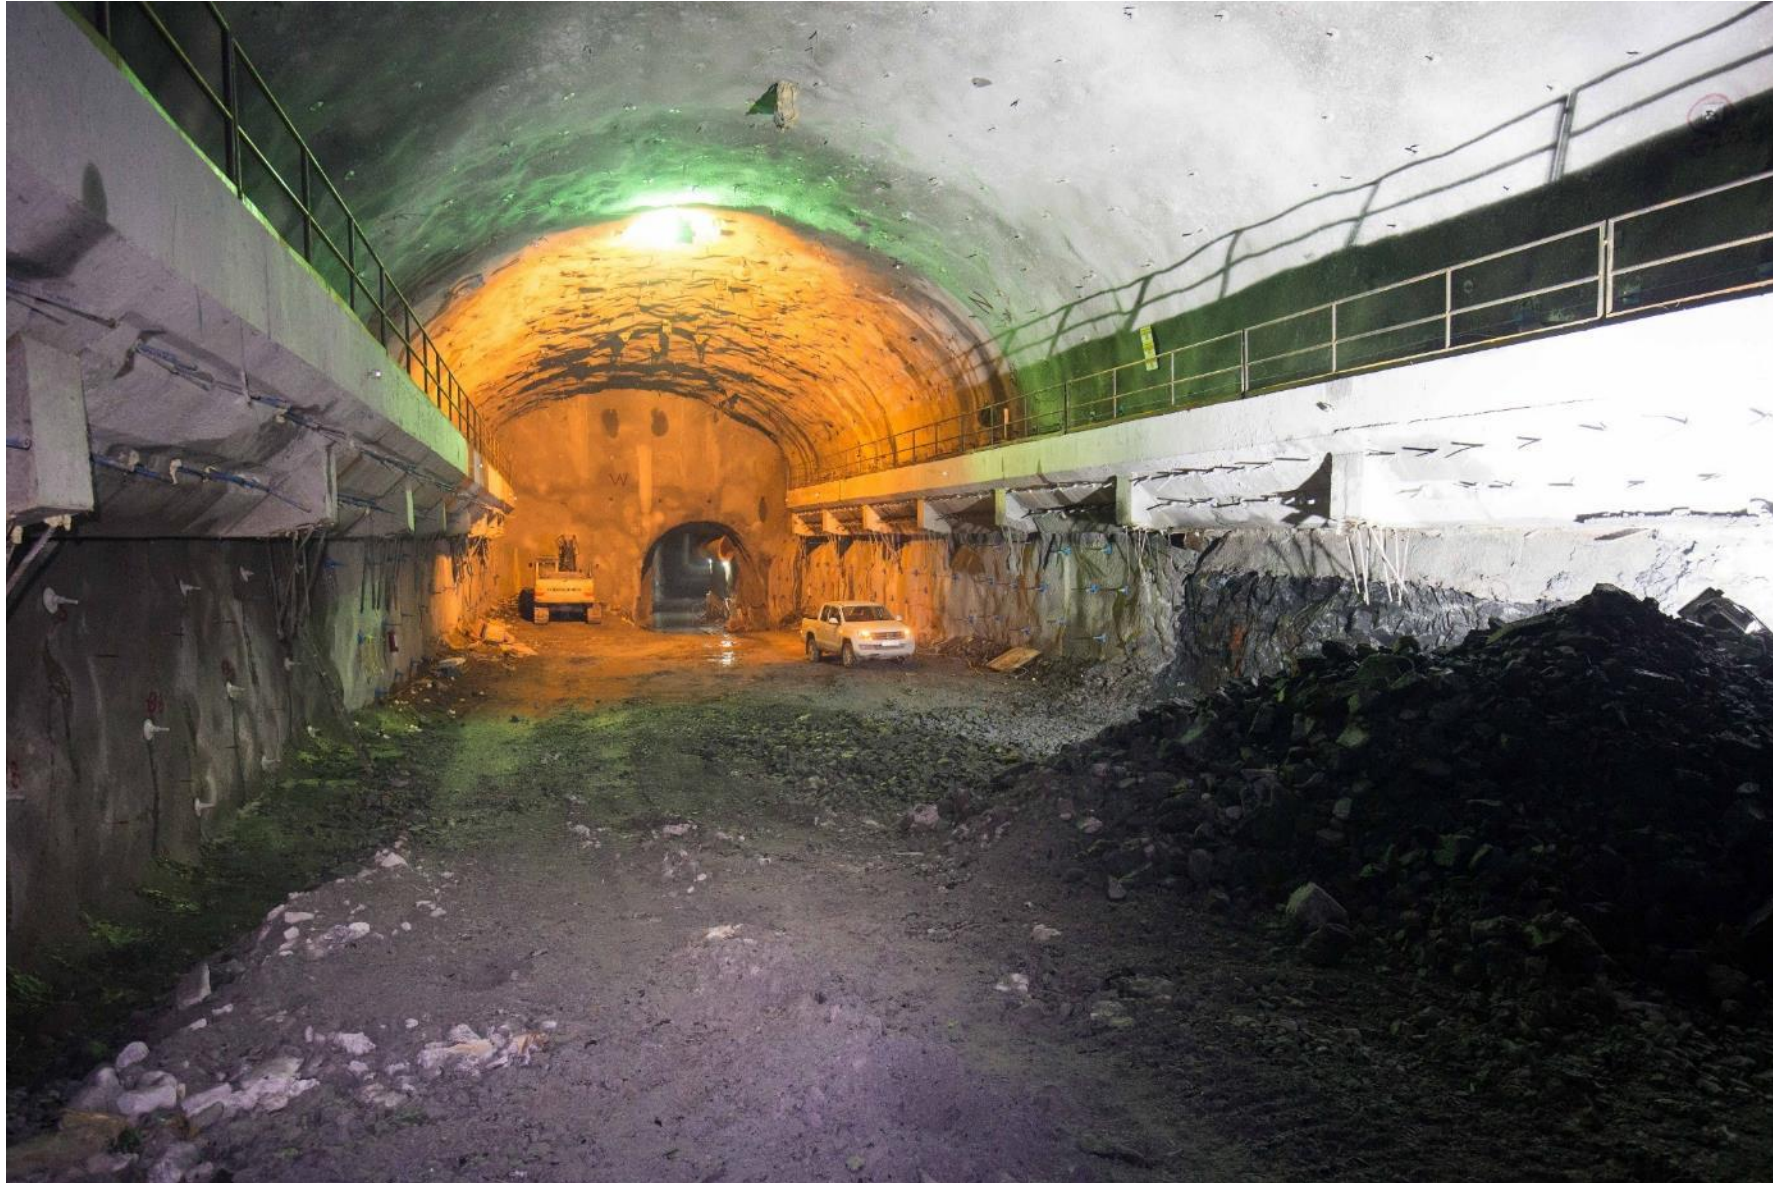
August 2016 Going below crane beams

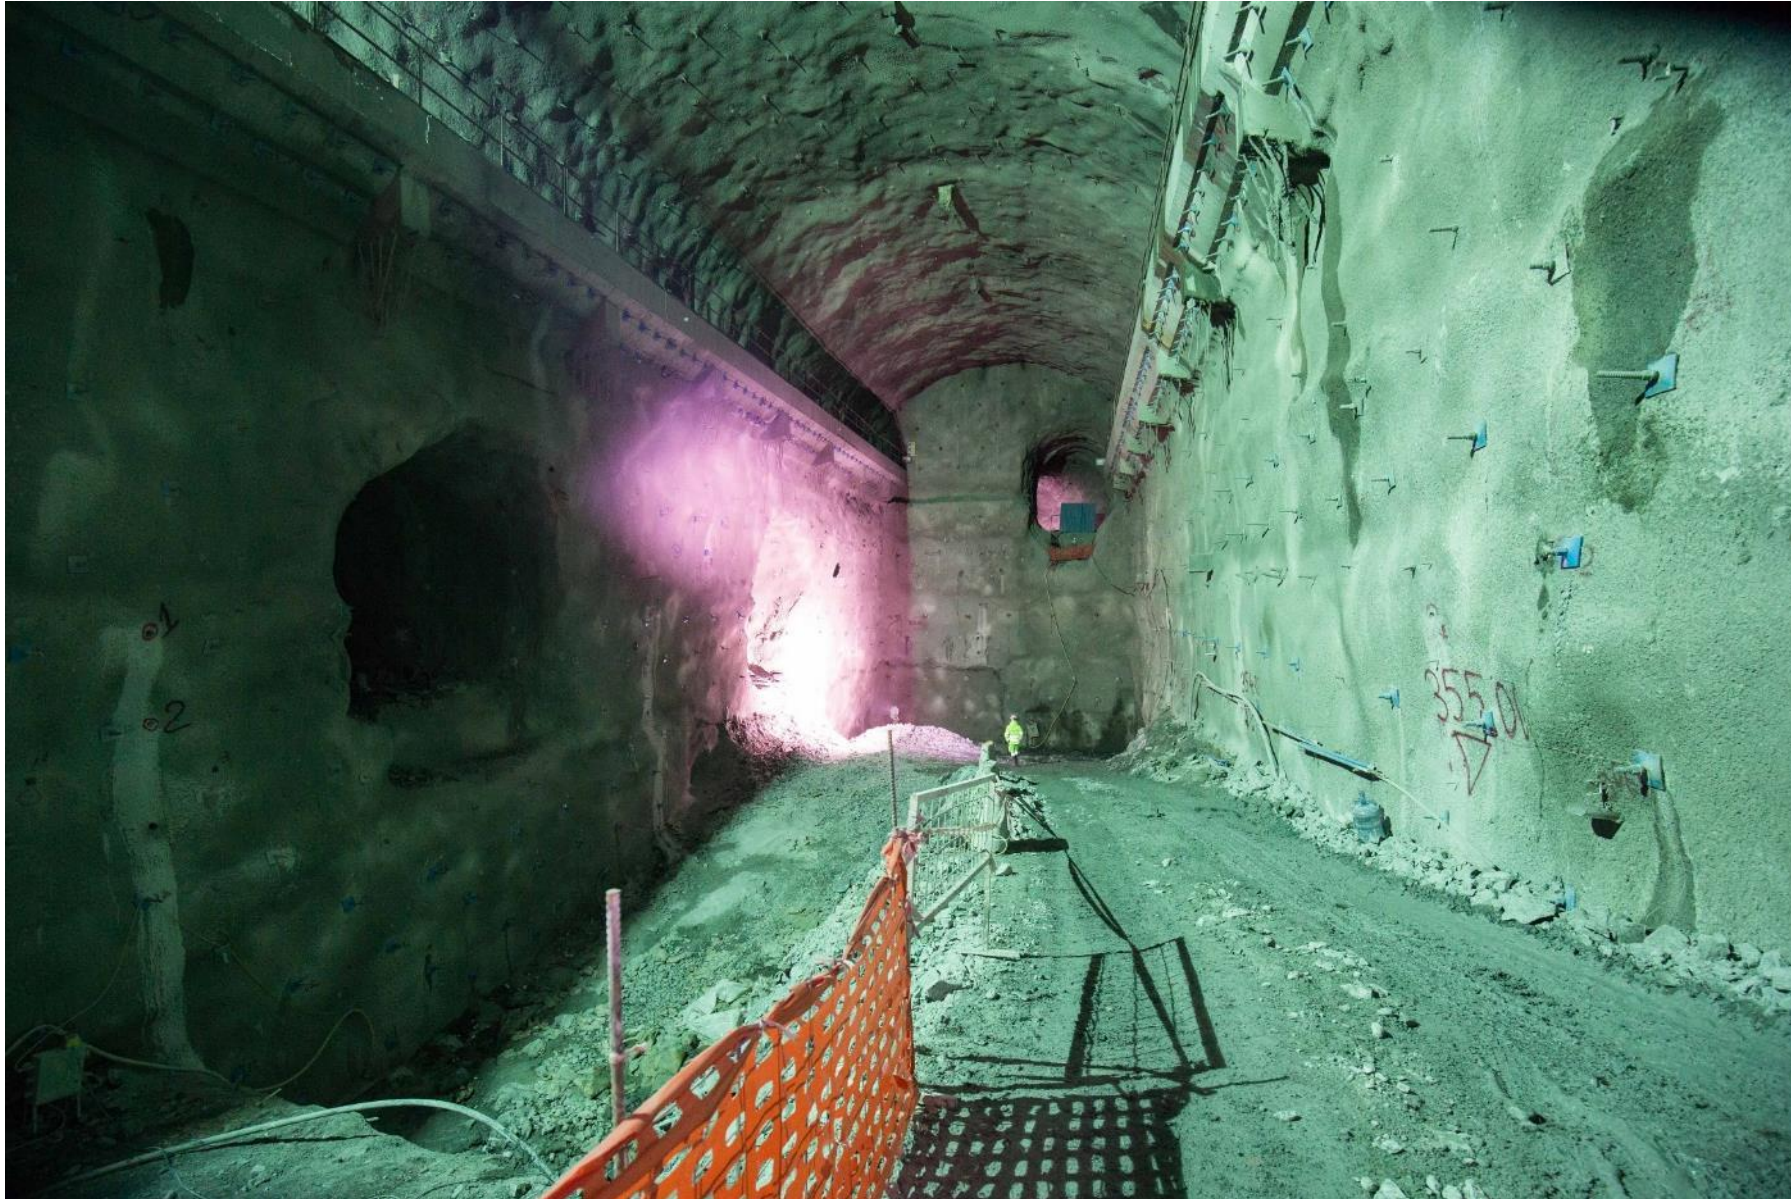
November 2016 Bus duct galleries

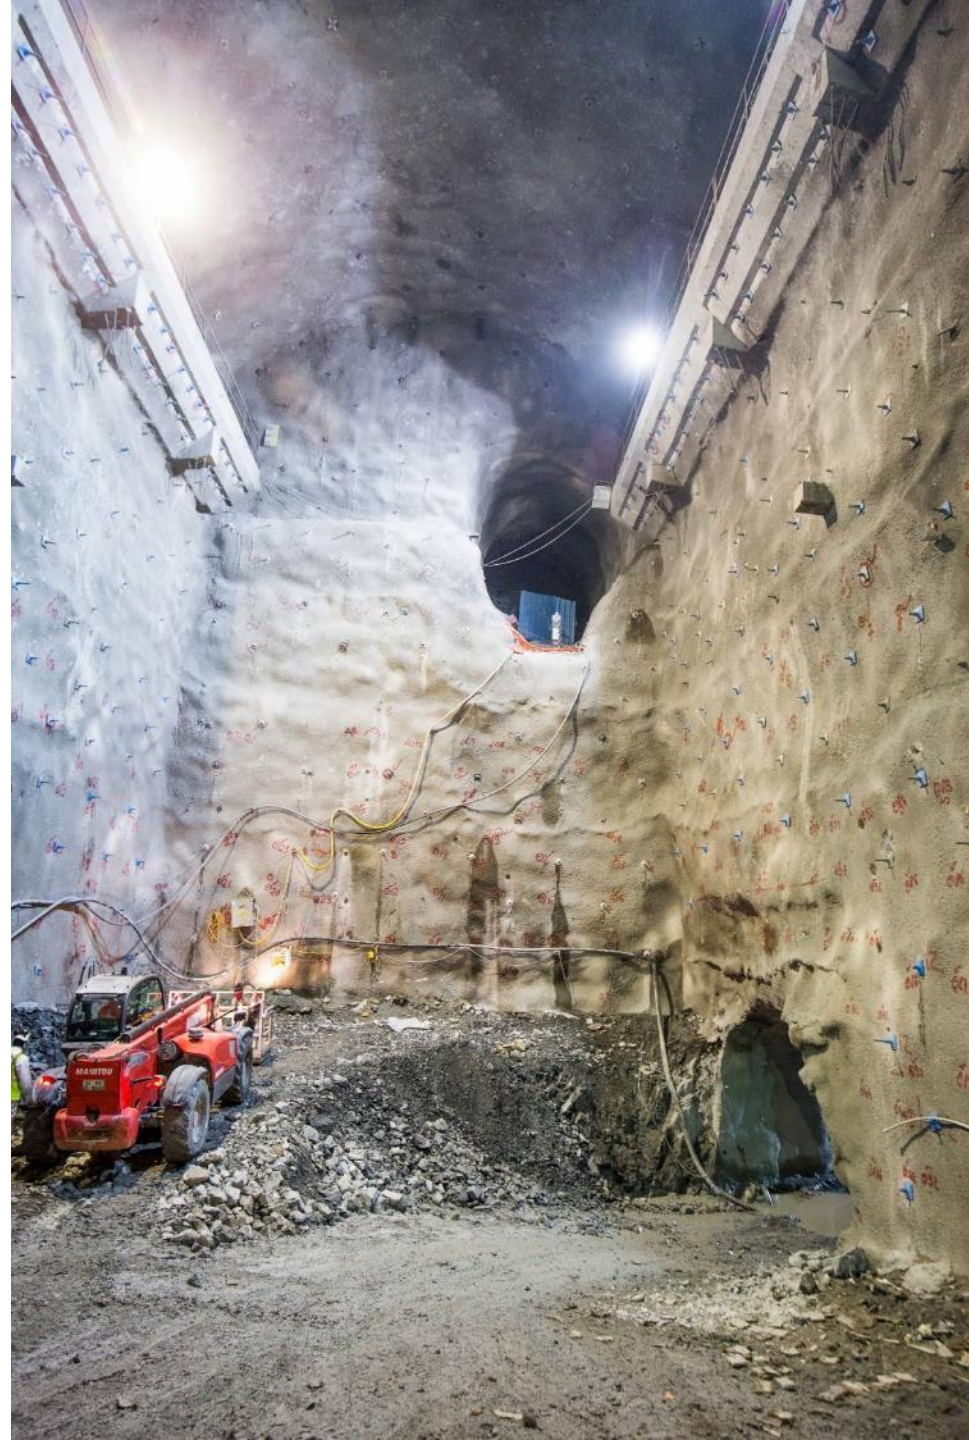
December 2016
Manifold tunnels level
reached

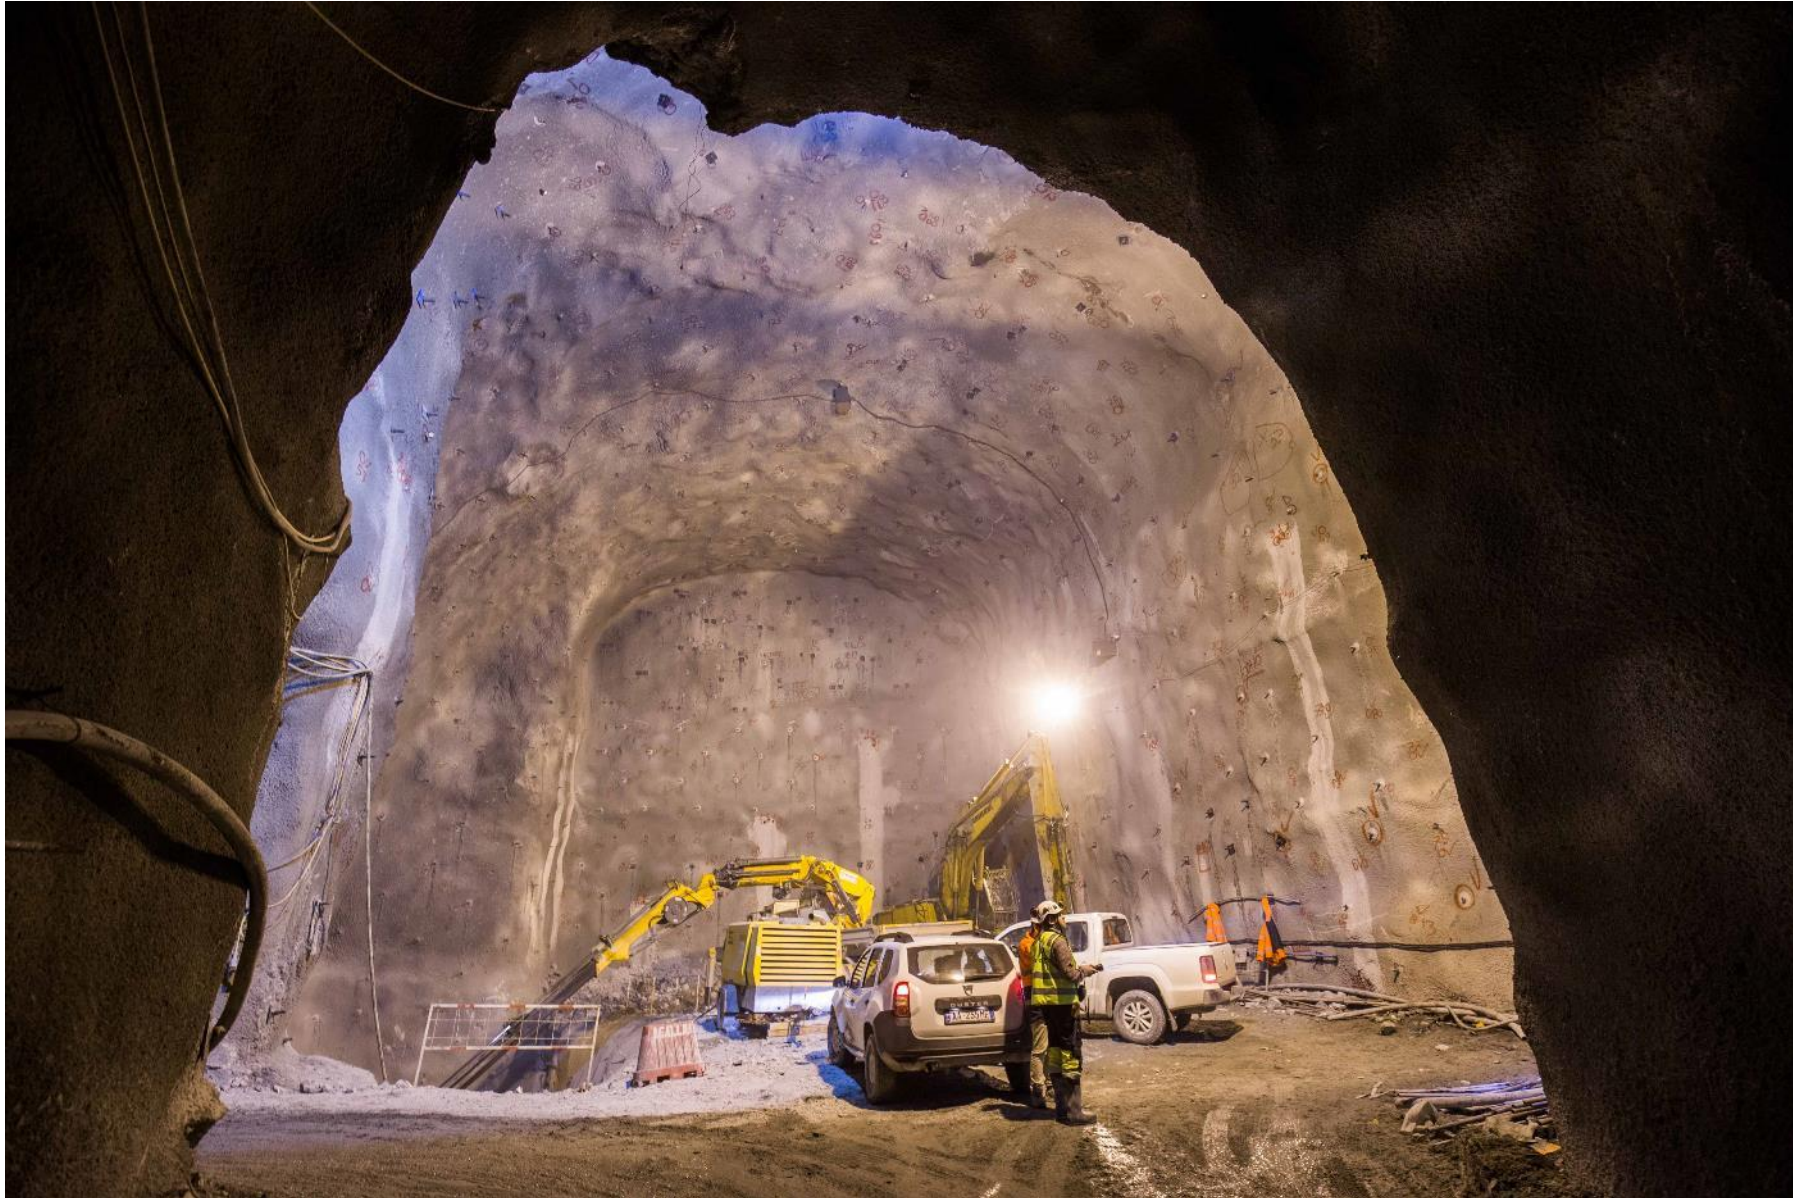
January 2017 Transformer cavern excavated

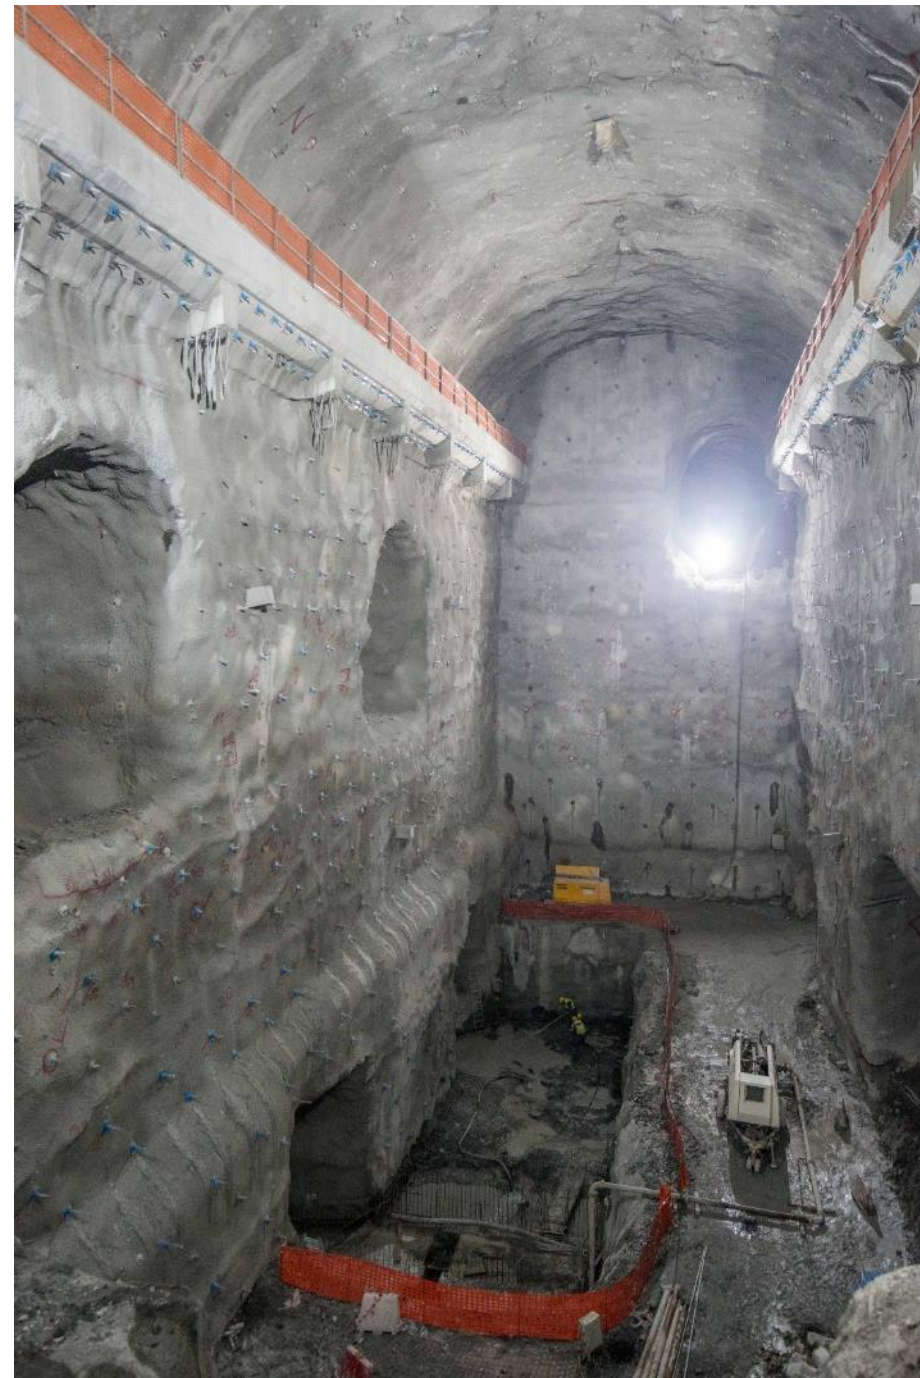
February 2017
Both caverns excavated
