Anvendt Bergmekanikk – 10/01/2018

PRAKTISKE EKSEMPLER FRA ANVENDT BERGMETKANIKK I GRUVEINDUSTRIEN

Nghia Trinh – SINTEF Byggforsk

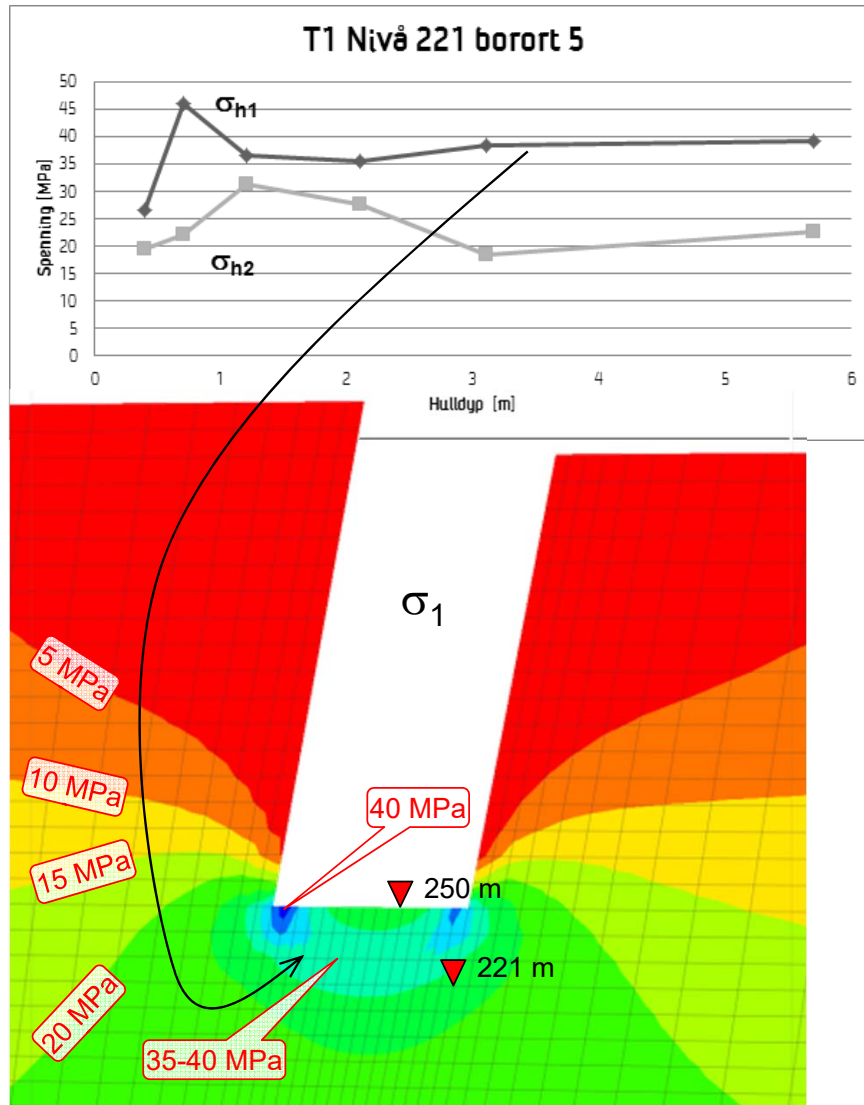
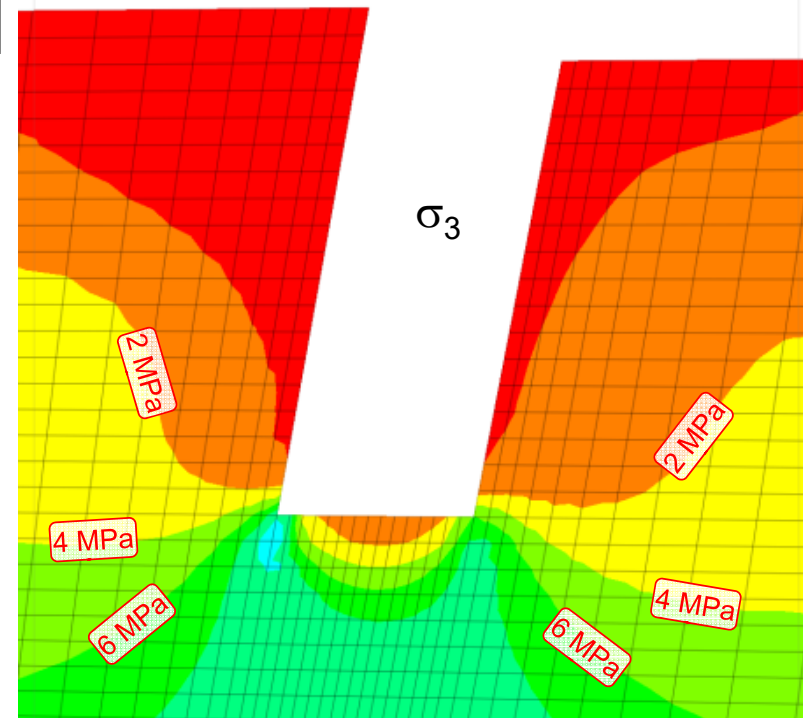
- Case 1: Result of the SINTEF's measurement - verification:

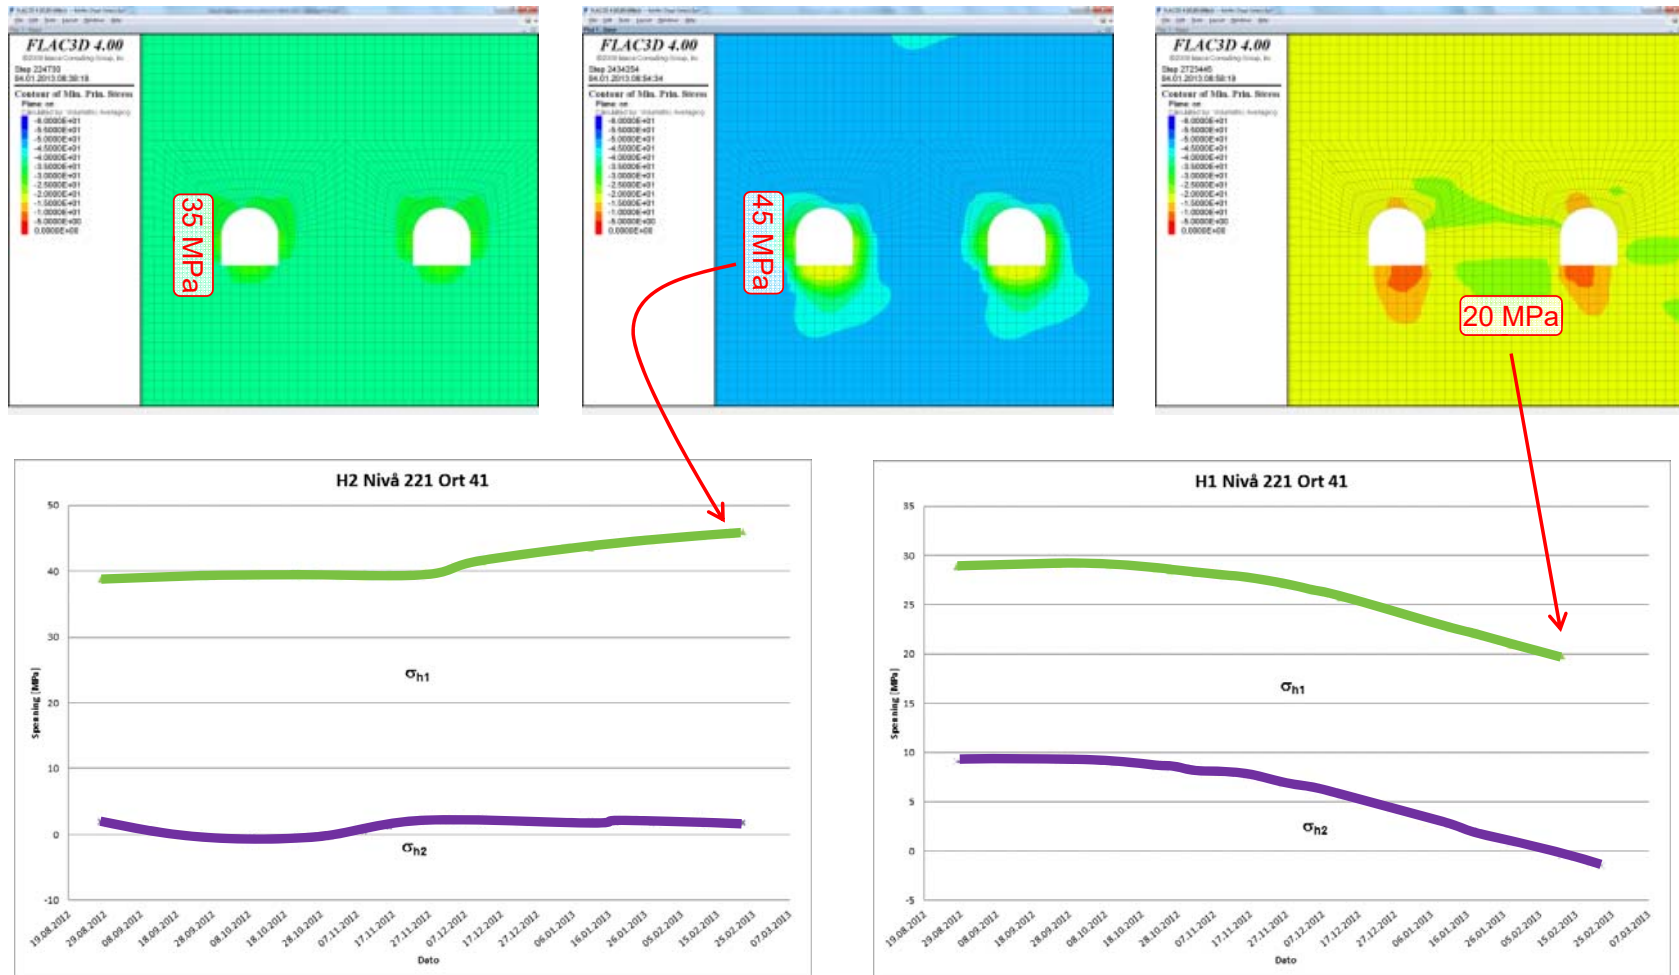
- Stress in a pillar and verification:

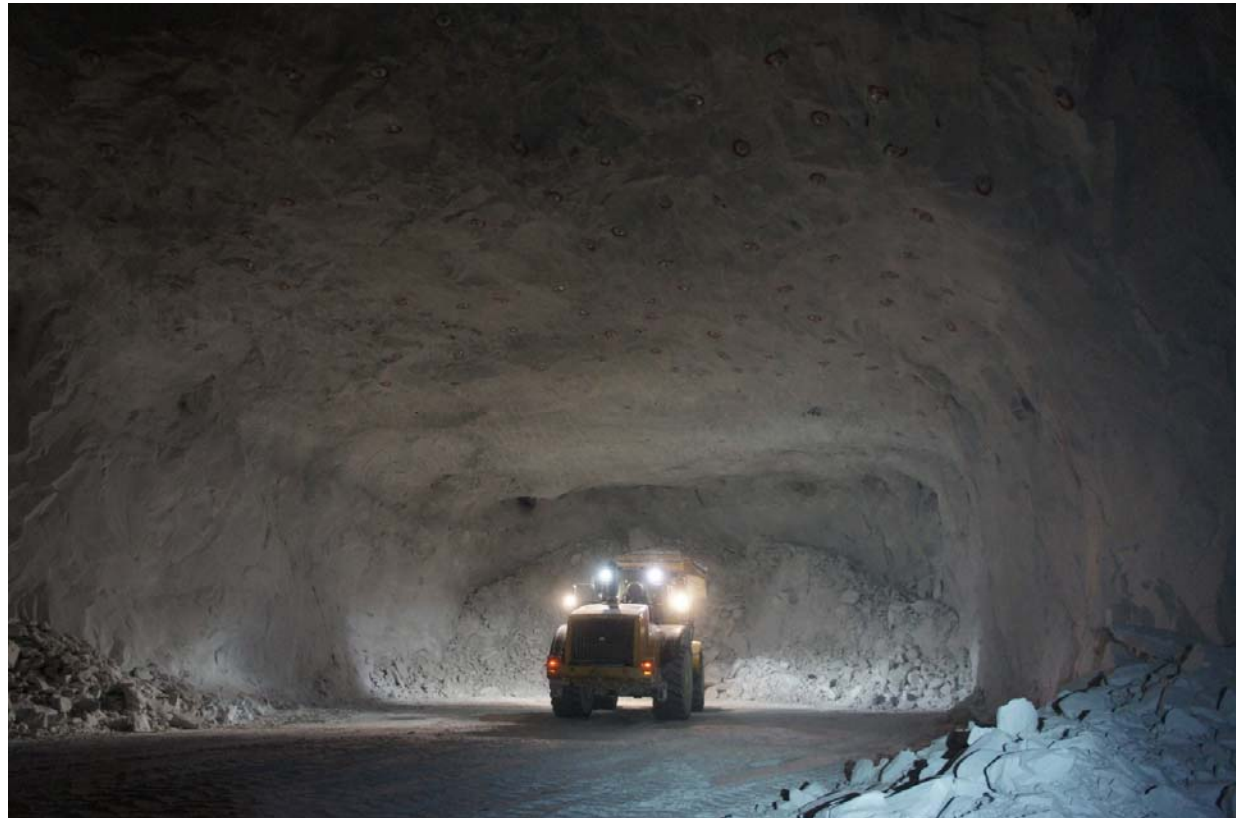
- "High stress" can be utilised in this mine to make a large span room;
- To make this possible, it is necessary to know the stress orientation and magnitude...;
- One should also note that geological structural (faults, fold,..) may affect the orientation and magnitude of in-situ stress locally.

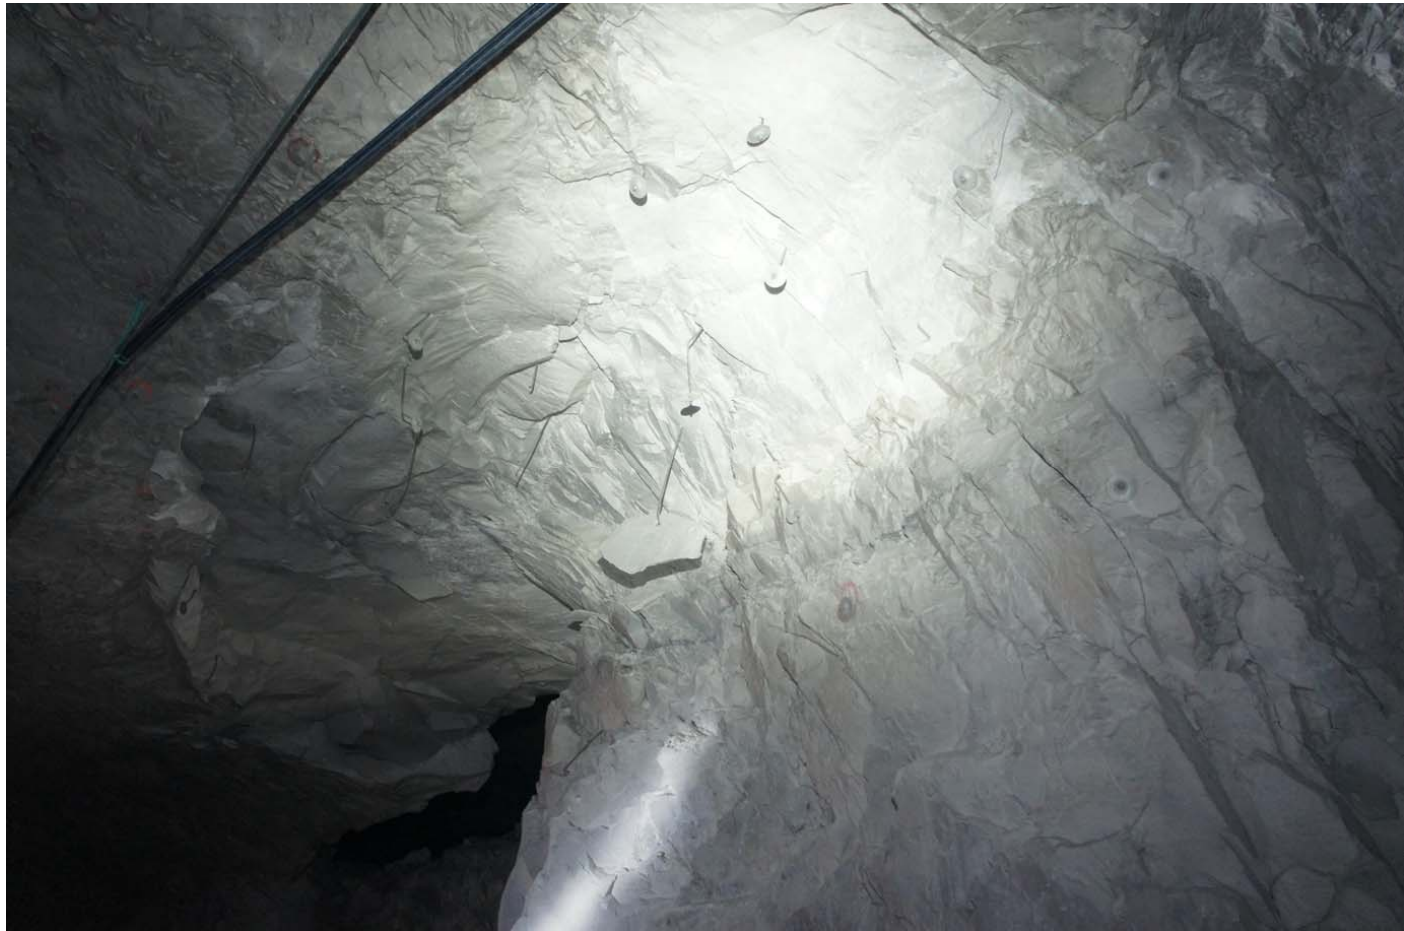
Some rock falls

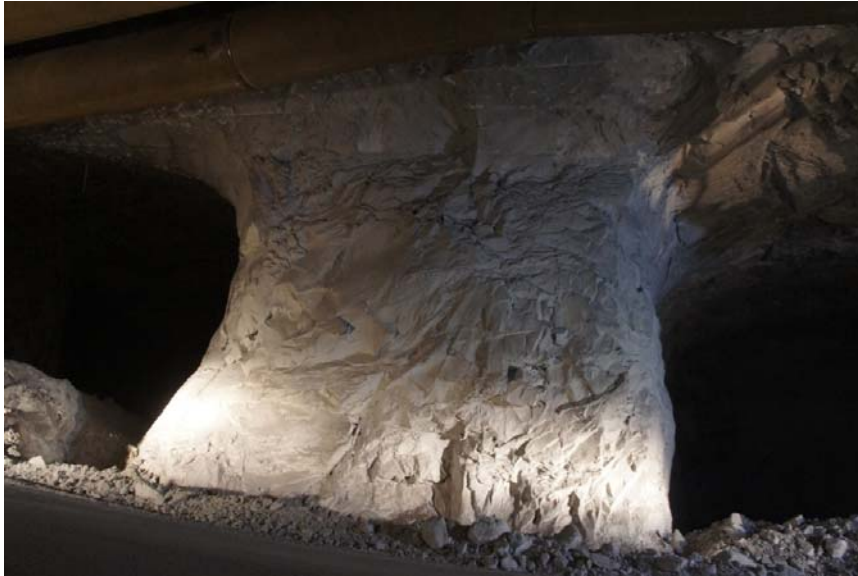
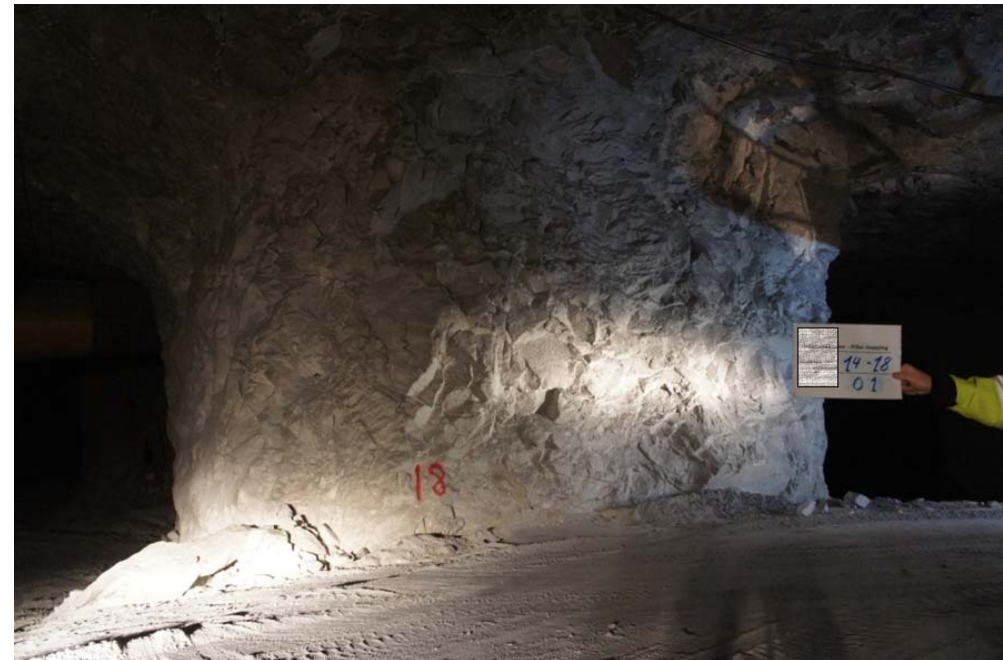
- Typical pillars without instability concern:

"Generally Stable" group: pillars in this group are in overall showing a stable situation:

- Very minor slabbing, local fractures, or few individual unfavourable joints are observed;
- Slabbing, fractures, and joints are local, no risk of further development that could lead to a gradual, progressive failure.
- No systematic rock support is required except spot bolting needed to keep the pillar supporting the roof of the mine in a long term.

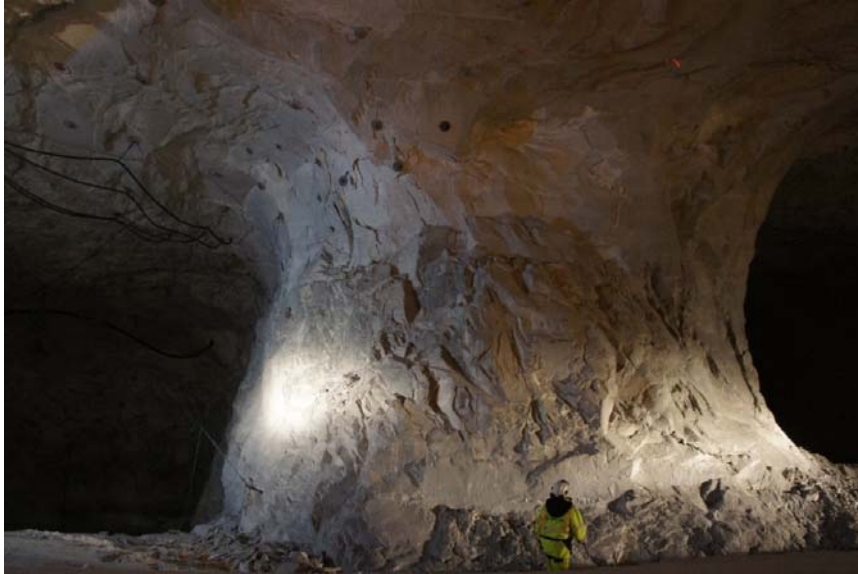
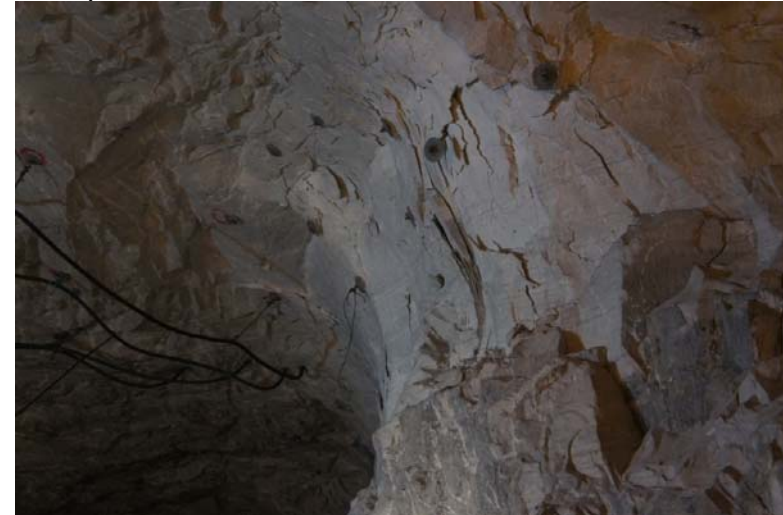
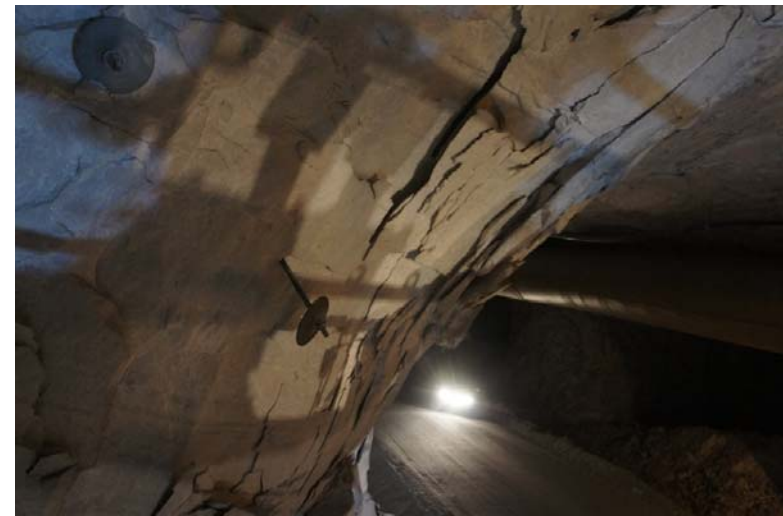
- Typical pillars with instability concern (10-12/05):

"Minor/Medium Slabbing" group: pillars in this group expose an uncertain stability situation:

- Significant fractures are observed. The fractures may lead to a potentially unstable situation in the pillar and rock support is required in a long term;
- Rock slabbing appears in various degree from a noticeable to a significant area of the pillar;
- Working directly under the area is not recommended. Additional rock support measures is be required before working directly under an area with minor/medium slabbing;

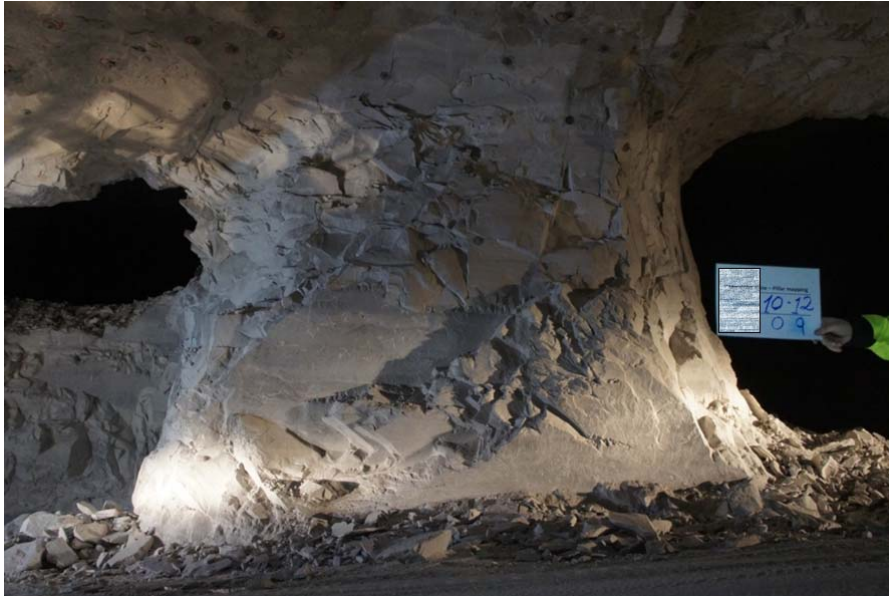
- Typical pillars serious instability problem (10-12/09):

"Unstable" group: pillars in this group expose an unstable situation. The following descriptors have been used for pillars in this group:

- Rock slabbing occurs in a very large part of the pillar. The slabbing leads to a progressive destabilisation and the pillar will eventually collapse;
- Rock fall may take place uncontrolled;
- Working directly under "Unstable Pillar" area is prohibited;

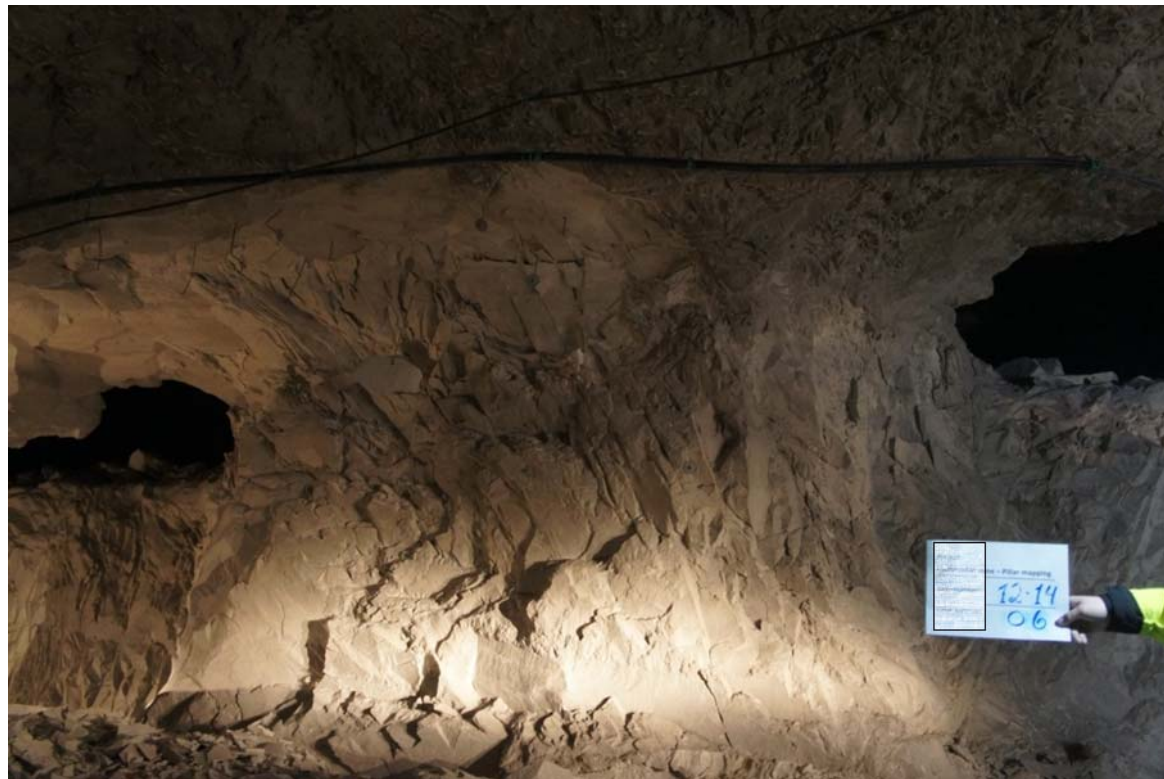
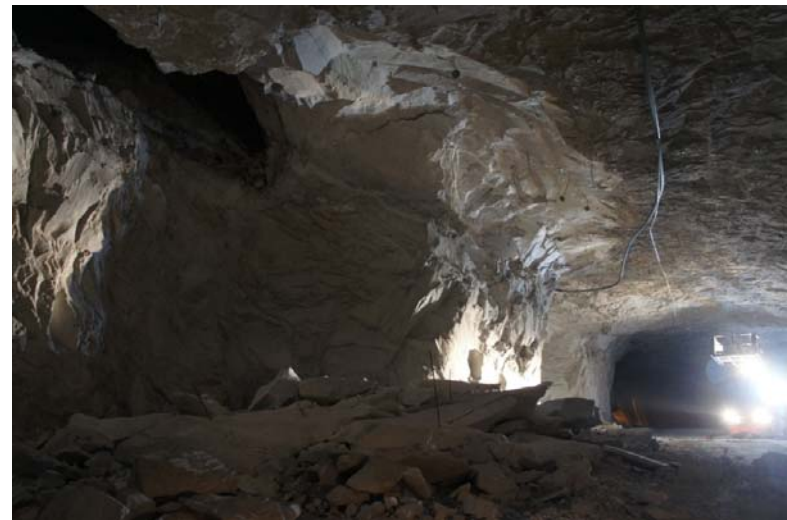
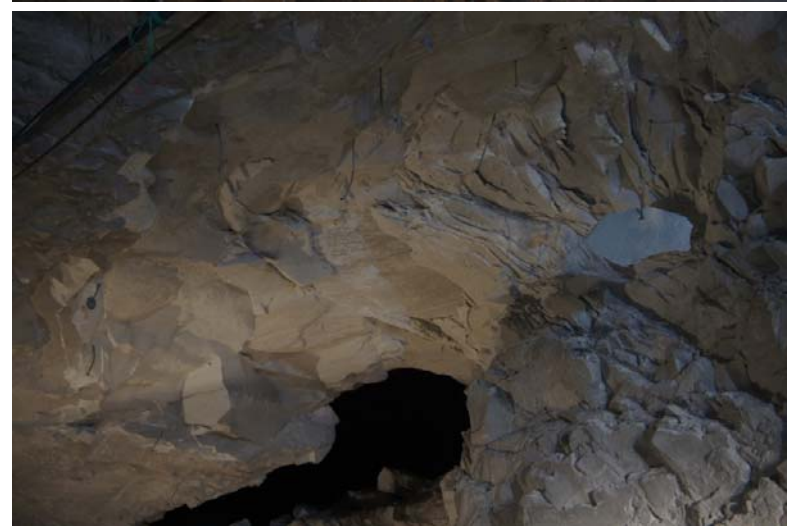
- Typical pillars serious instability problem (12-14/06):

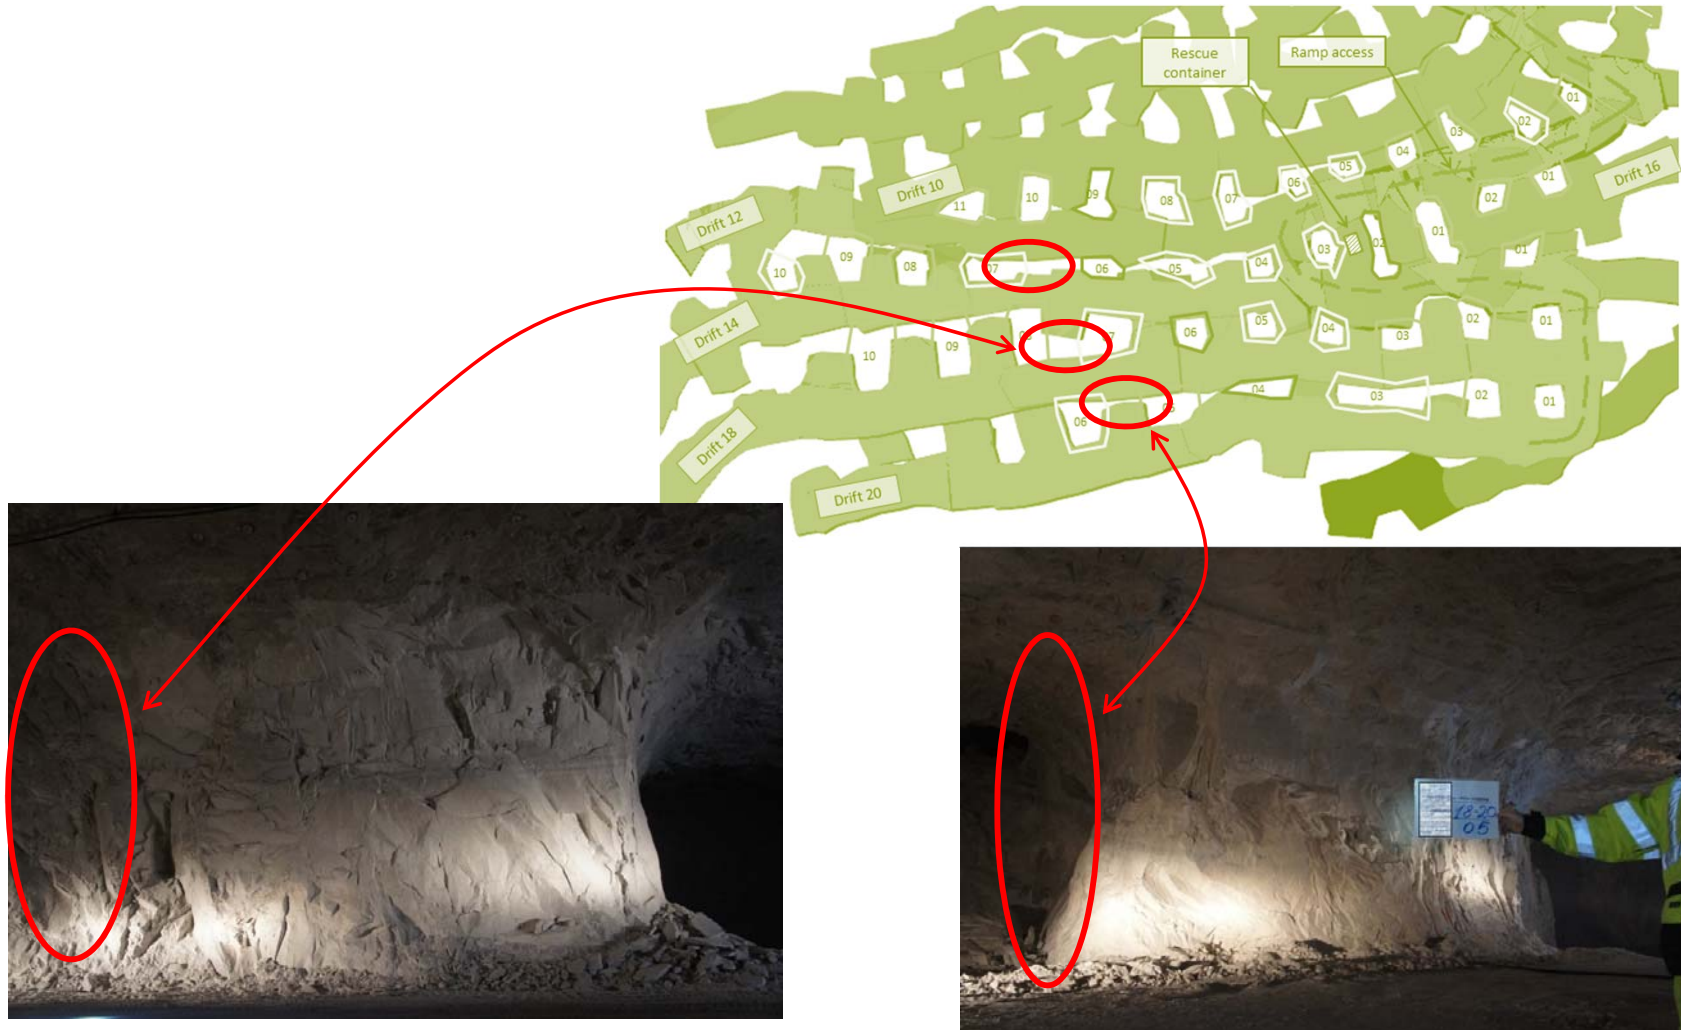
- Thin wall and its apparent condition:

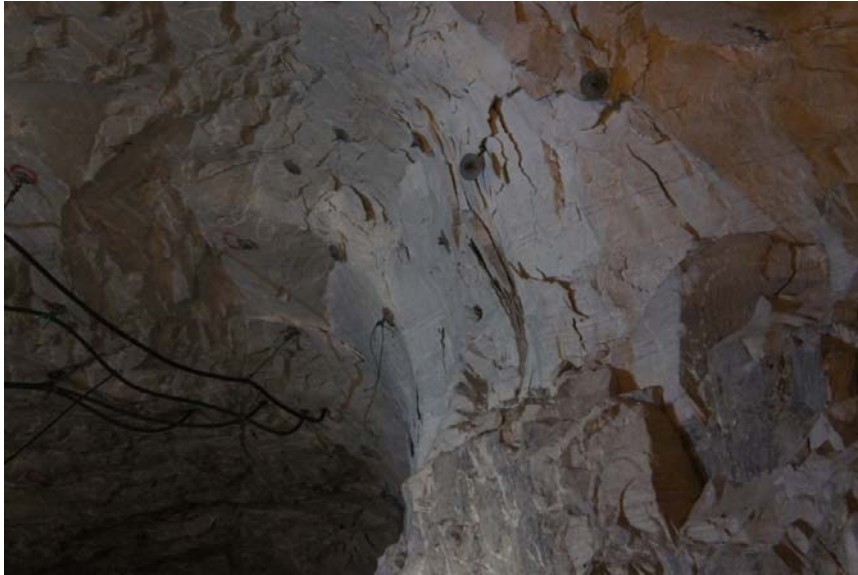
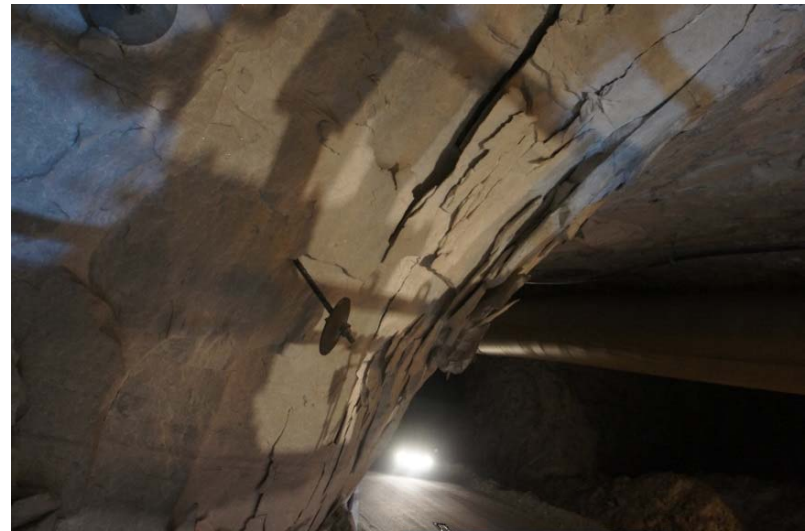
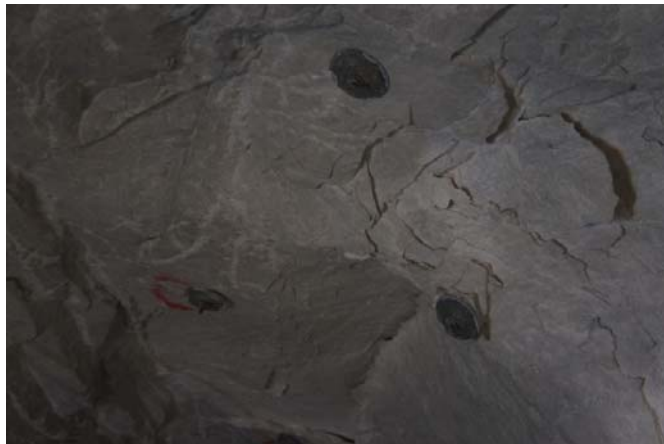
- Bolt in a high stress condition:

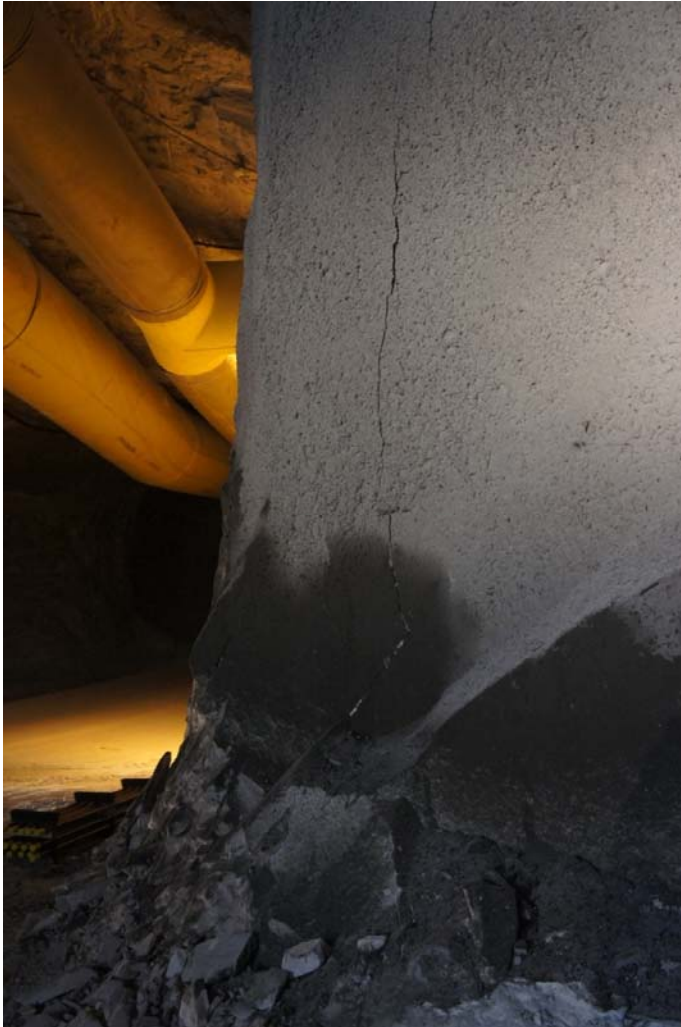
- Thin shotcrete should be avoided:
